HAMMOND POND DAM
PHASE I
INSPECTION / EVALUATION REPORT

Dam Name: Hammond Pond Dam
State Dam ID#: 2-8-108-1
NID#: MA00176
Owner: Hammond Acres Club
Owner Type: Private
Town: Goshen
Consultant: Tighe & Bond, Inc.
Date of Inspection: October 10, 2009

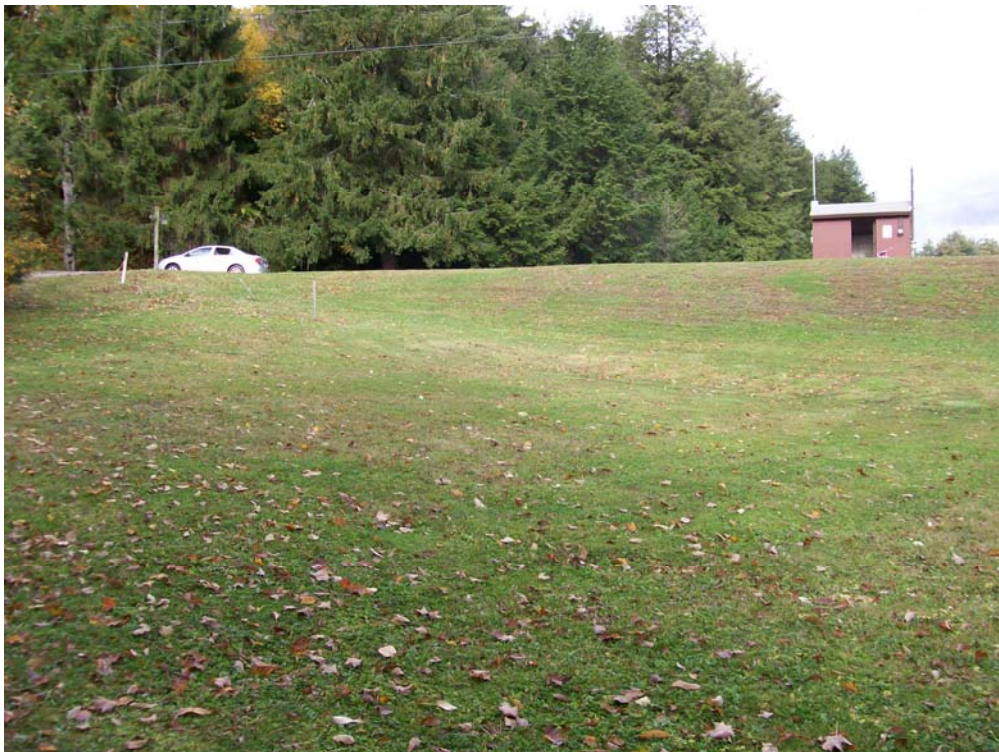
- There is a wet area at the downstream toe at the right abutment. It appears that this water is coming from the abutment slope as opposed to seepage through the dam. The dam owner plans to investigate this condition further.

Photo 4 - Downstream slope at right abutment.

ADDITIONAL COMMENTS: The wet area at the toe near the right abutment is believed to be caused by groundwater flowing down the slope from the right abutment. The dam owner is currently planning to install a curtain drain downstream of the right abutment to intercept, and redirect, the water past the downstream toe.

1. Install curtain drain as planned to eliminate the wet area at the downstream toe.
2. Rebuild the right upstream spillway training wall.
3. Add fill material along the downstream side of the embankment to decrease the slope.
4. Repair concrete wall on upstream face to the right of the gatehouse, or place rip rap upstream of wall to prevent possible collapse and erosion of embankment behind wall.
5. Repair potholes that develop in the gravel roadway on the dam crest.

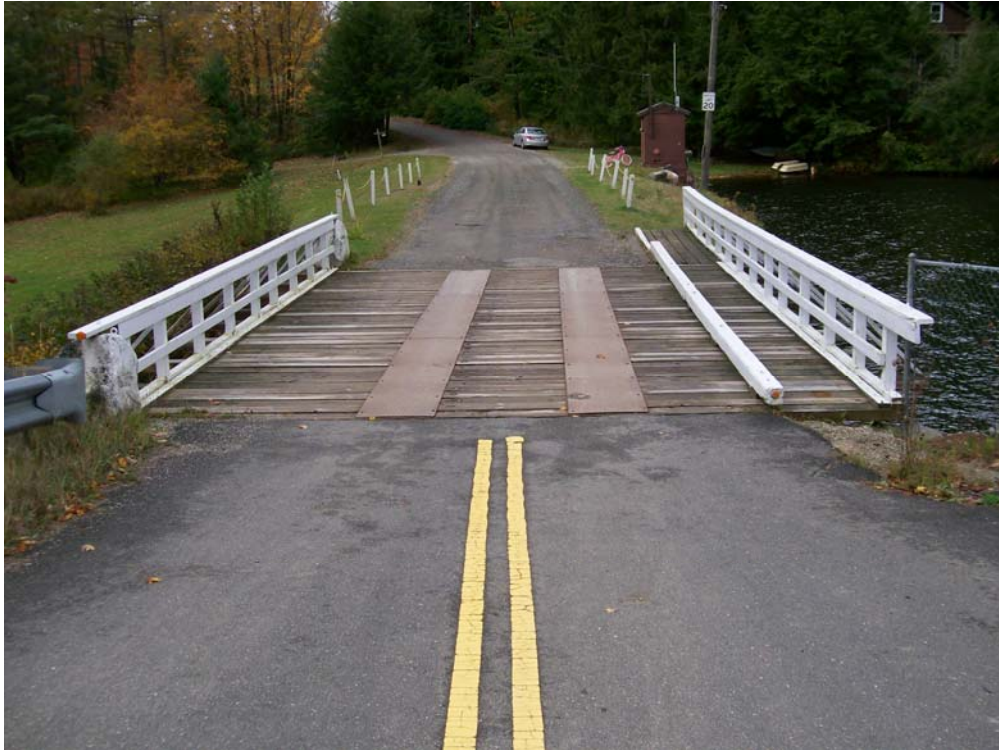
- **Crest** (photos 2, 3, 4, 5, 6 & 7)
 - The gravel road on the dam crest is well maintained. A small pothole was observed near the bridge. During periods of excessive rain, small potholes sometimes appear, but are later repaired.

Photo 7 - Dam crest viewed from the left abutment.

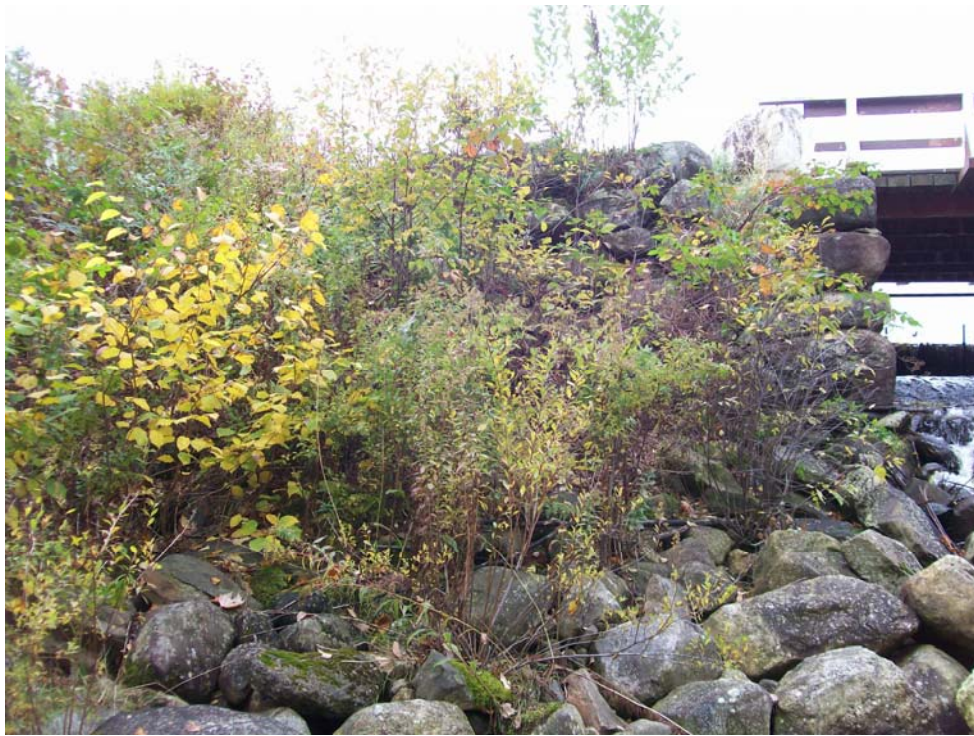
Photo 11 - Vegetation growing within rip rap surface on the downstream slope adjacent to the spillway.

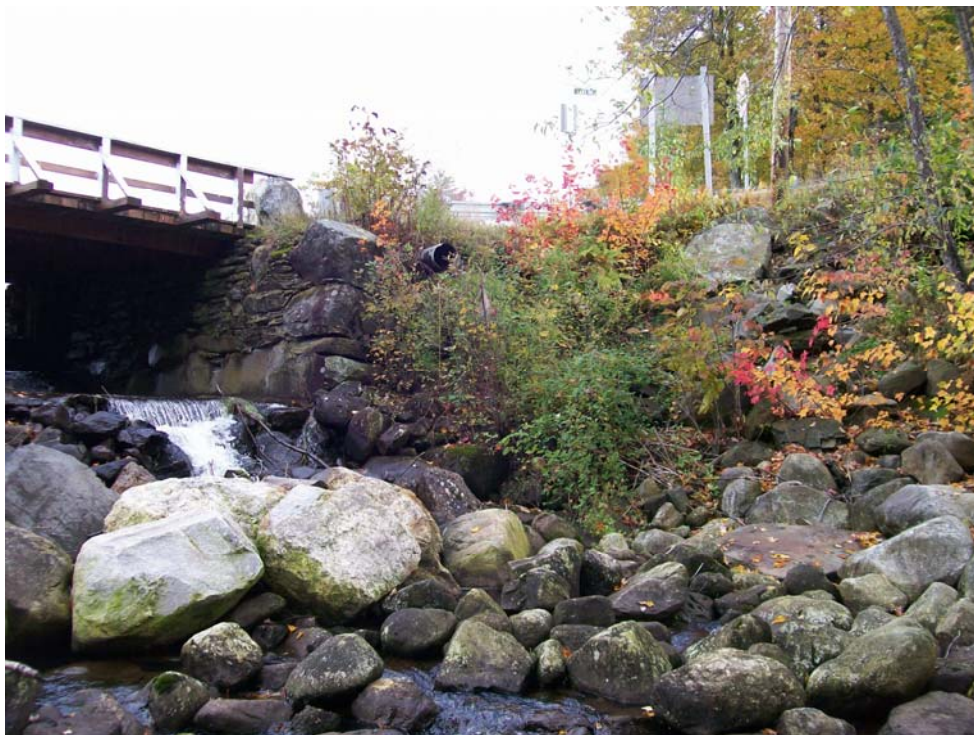
Photo 12 - Vegetation growing within rip rap surface on the downstream slope at the left abutment.

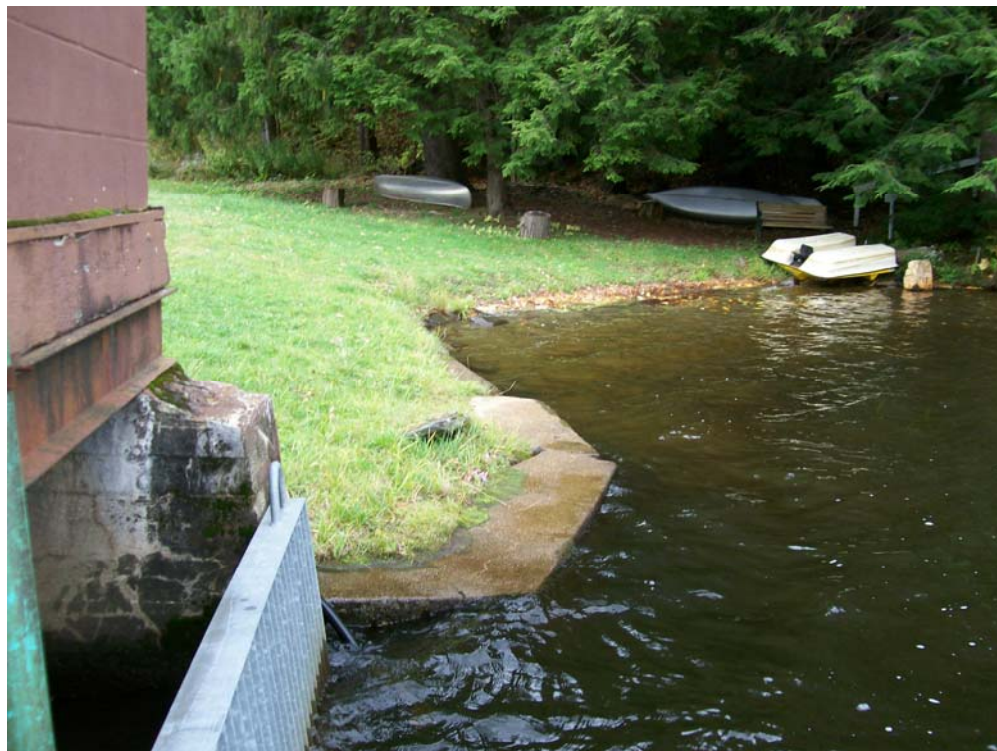
- The area to the right of the gatehouse is no longer used for storing boats. The shallow rut in the slope caused by dragging boats in and out of the water, noted previously, has been repaired and a well-maintained vegetative cover has been established.

Photo 17 - Upstream slope at right abutment. Note repairs made to previously reported erosion.

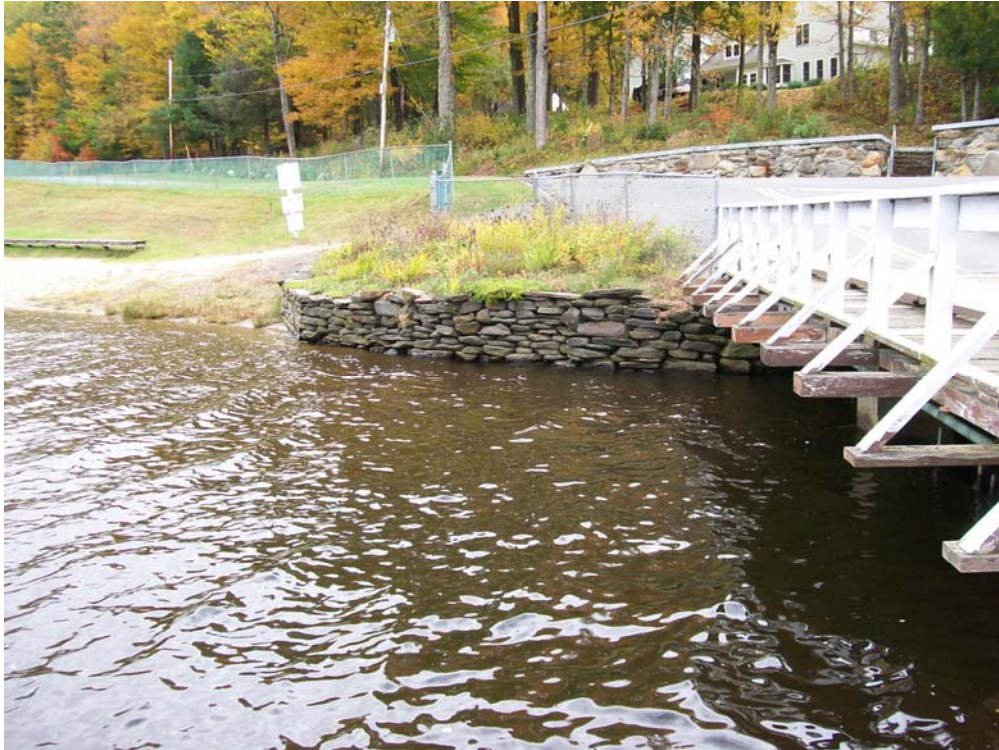
- The field stone masonry training wall on the left upstream side is in good condition.
- The stone masonry training wall on the right upstream side is in poor condition, but has stayed relatively unchanged for many years. The wall has separated from the bridge abutment and is leaning towards the impoundment with soil settlement occurring behind the wall at the embankment interface.

Photo 19 - Field stone masonry training wall at upstream left side of spillway.

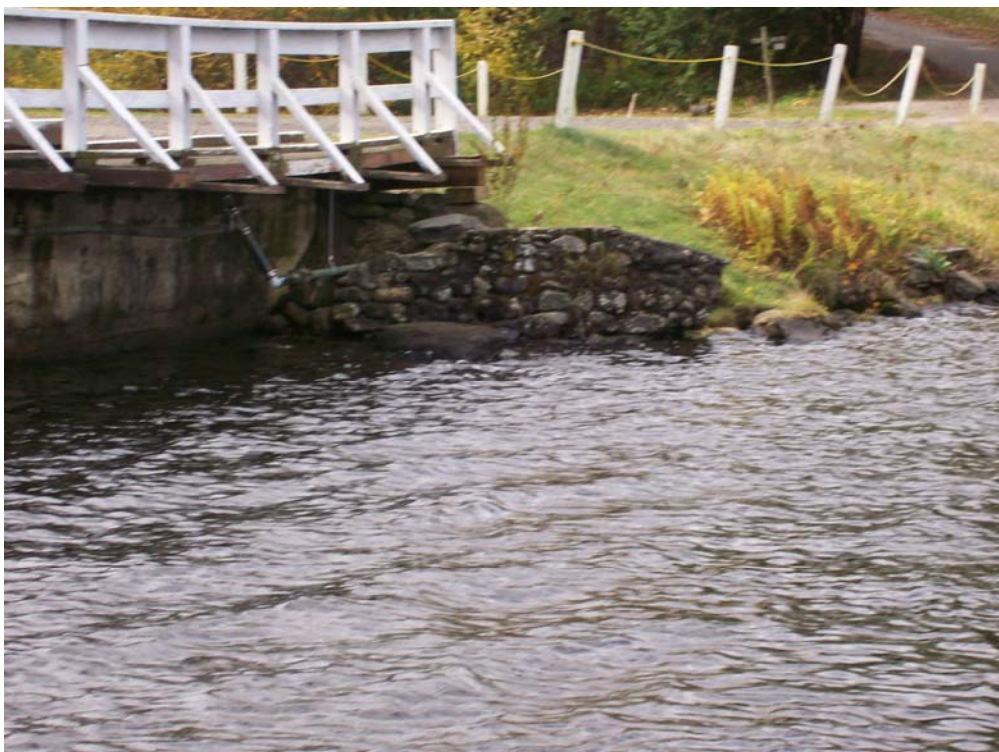
Photo 20 - Stone masonry training wall at upstream right side of spillway.

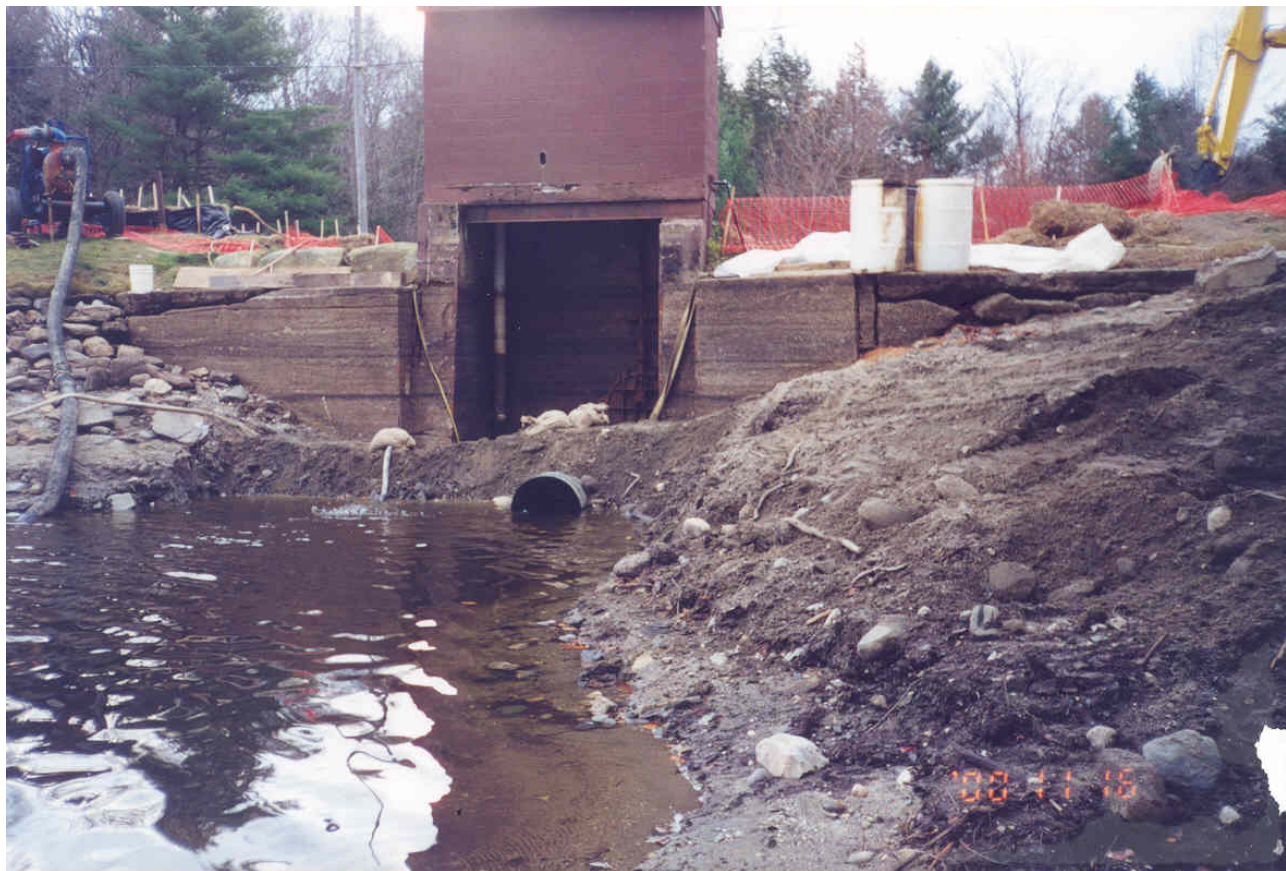
- The cracks in the concrete retaining walls at the upstream face adjacent to the gatehouse have been noted in several previous inspection reports and the conditions have not changed. The cracks and separations in the concrete retaining wall observed to the right of the gatehouse are actually in a wall section that is not part of the same pour for the gatehouse foundation. The crack observed at the left side of the gatehouse is part of a horizontal crack that separates the top 4 to 6 inches of the wall at the end not connected to the foundation. See photo 23 included in Appendix A. These deficiencies do not impact the condition of the gatehouse, or its' foundation.

Photo 23 - Photo taken during the construction of the improvents at Hammond Pond Dam in 2000. This photo shows that the cracks in the concrete to the left and right of the gatehouse are at locations that are not part of the gatehouse foundation and do not present a threat to the structural integrity of the gatehouse, or the embankment.

| | Recommendation | Probable Cost |
|---|---|---|
| 5 | Repair the concrete wall on the upstream face to the right of the gatehouse, or place rip rap upstream of the wall to prevent possible collapse or erosion of the embankment behind the wall. | \$4,000 |
